R2 MARIA Waste Water Assessment Form v1.0

Oct 11, 2017

AES Puerto Rico

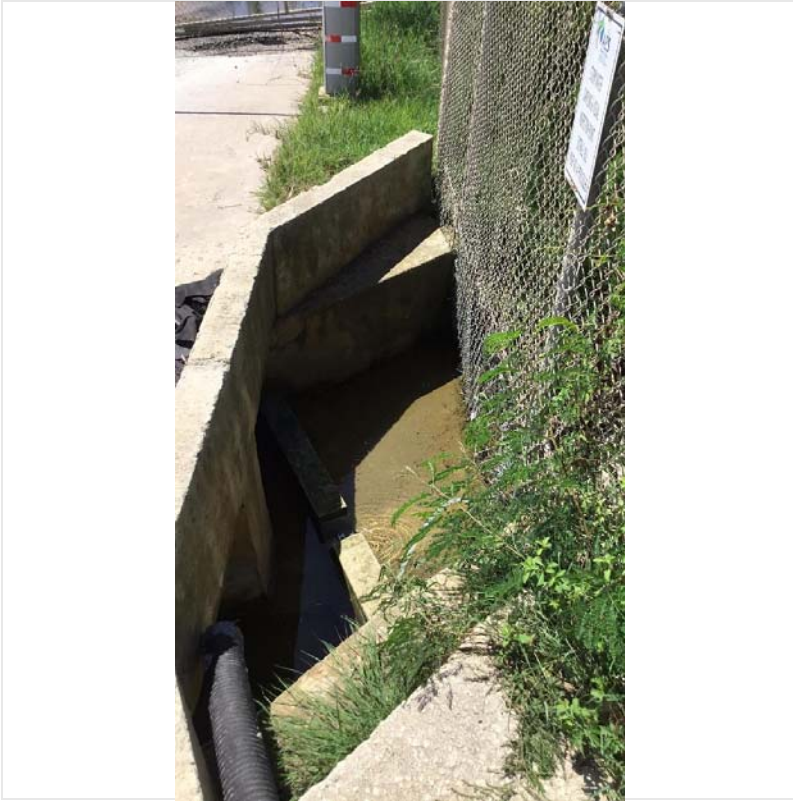
SM_A5-20171012-151305.jpg

1. Outfall 002. 2. Stormwater drainage around aggregate pile. 3. Stormwater draining off coal pile into pond (discharged to makeup pond for facility use). 4. Coal pile holding pond. 5. Storm water pond.
